Tender No: MSC-2024-001

Forward Remote Capital Program

APPENDIX 1

Subject: Geotechnical Investigation – 254 Wardirrkkan Street, Gununa, Mornington Island

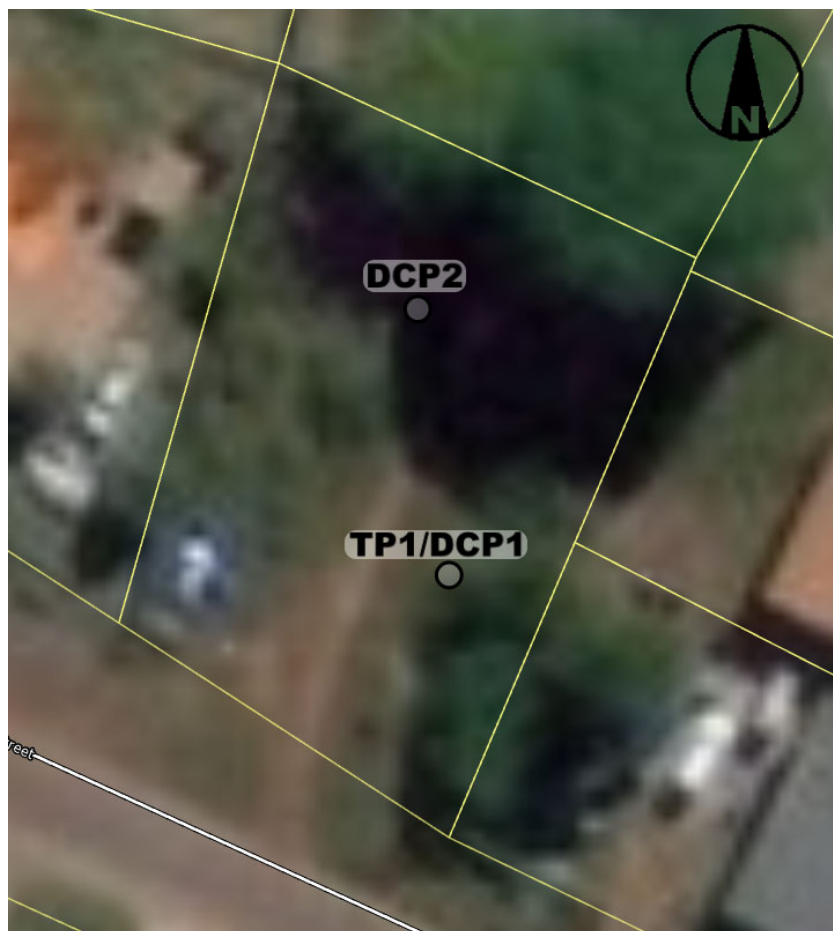
Test locations are shown in Figure 1. Test locations were limited by the presence of vegetation, rubbish and potential services.

Figure 1 - Test locations

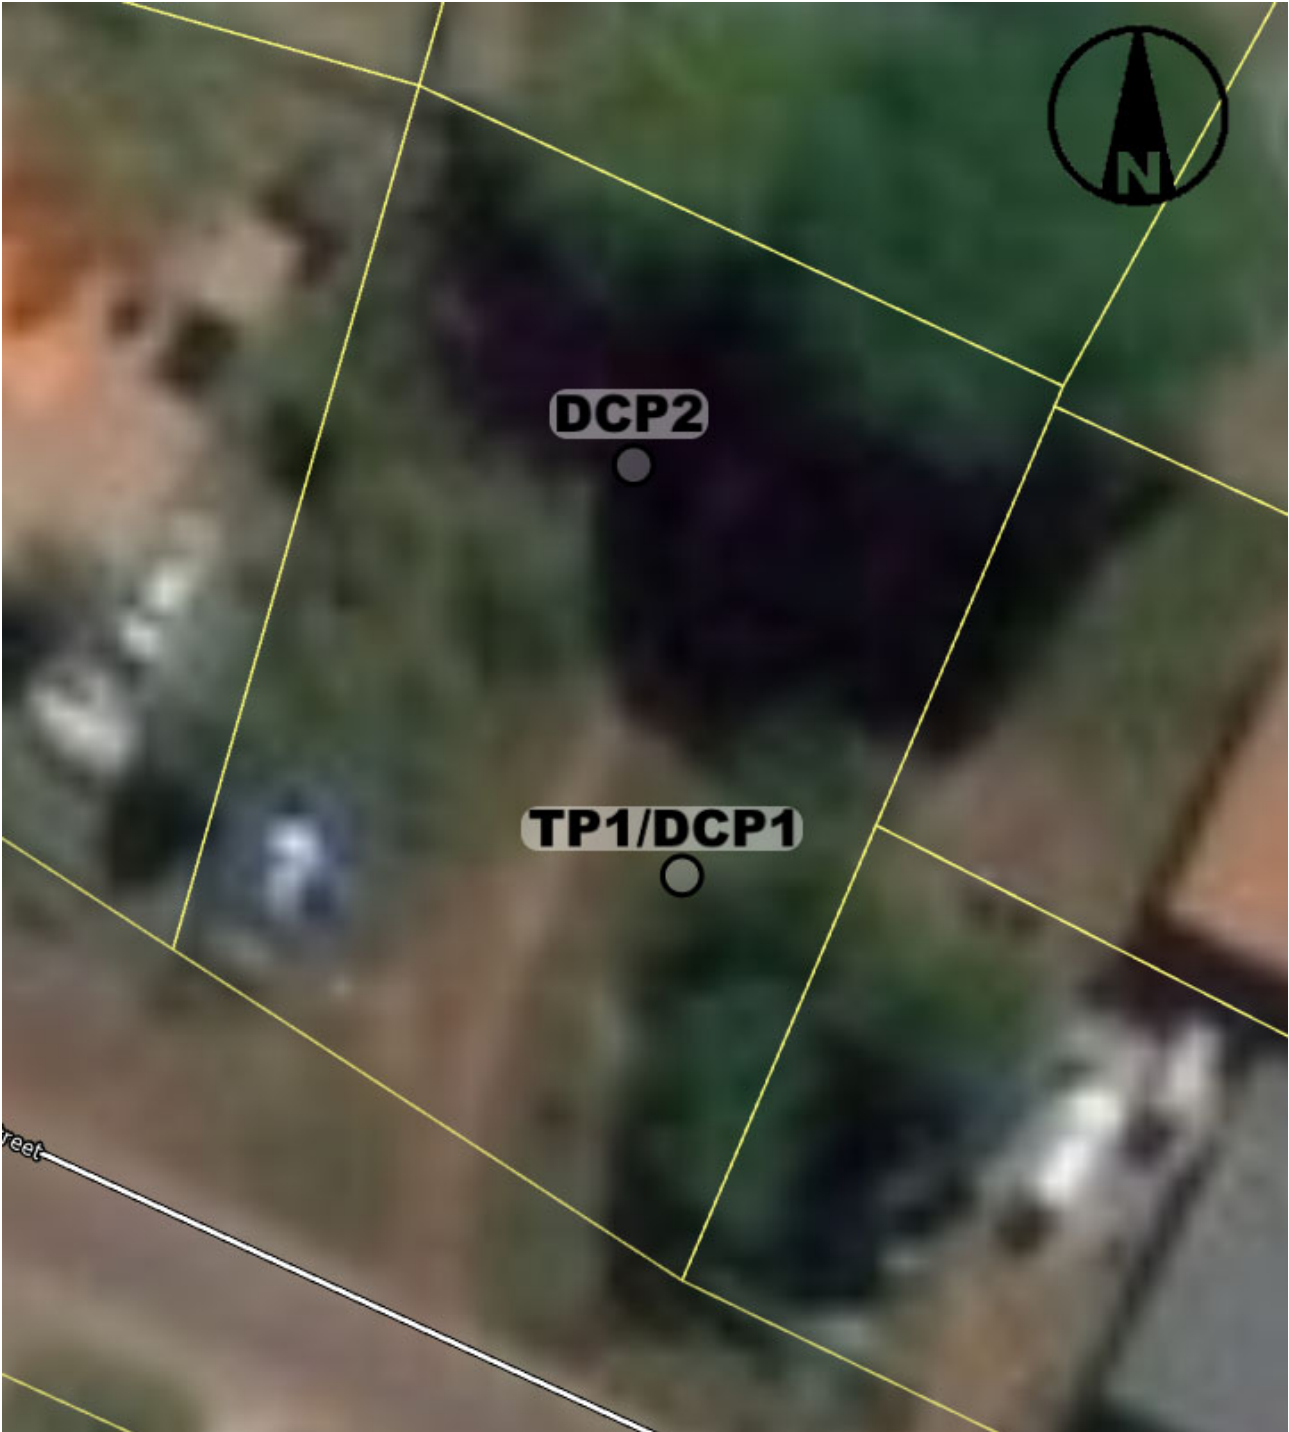
APPENDIX A. TEST PIT/DCP LOGS

LOCATION	EASTING (GDA2020)	NORTHING (GDA2020)
22260_2 TP1/DCP1	305581.86	8156655.60
22260_2 DCP2	305580.03	8156669.97

Depth (m)	Lithology	Description/Comments	Sample	Density	Dynamic Cone Penetration (per 100mm)	Depth (m)
0.00	FILL	FILL, SAND, fine grained, pale brown, moist, contains rootlets.	0.8m	VL	14	0.00

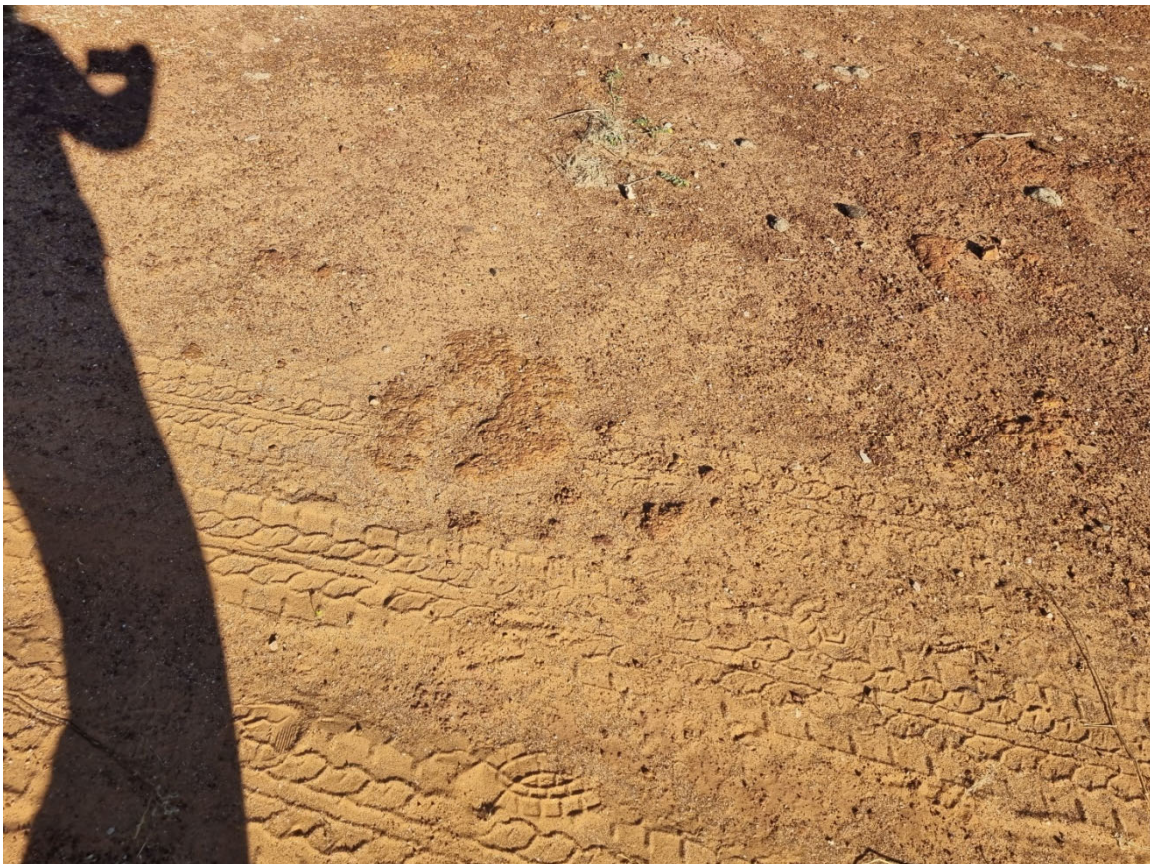
Photo 2 – Exposed laterite at surface

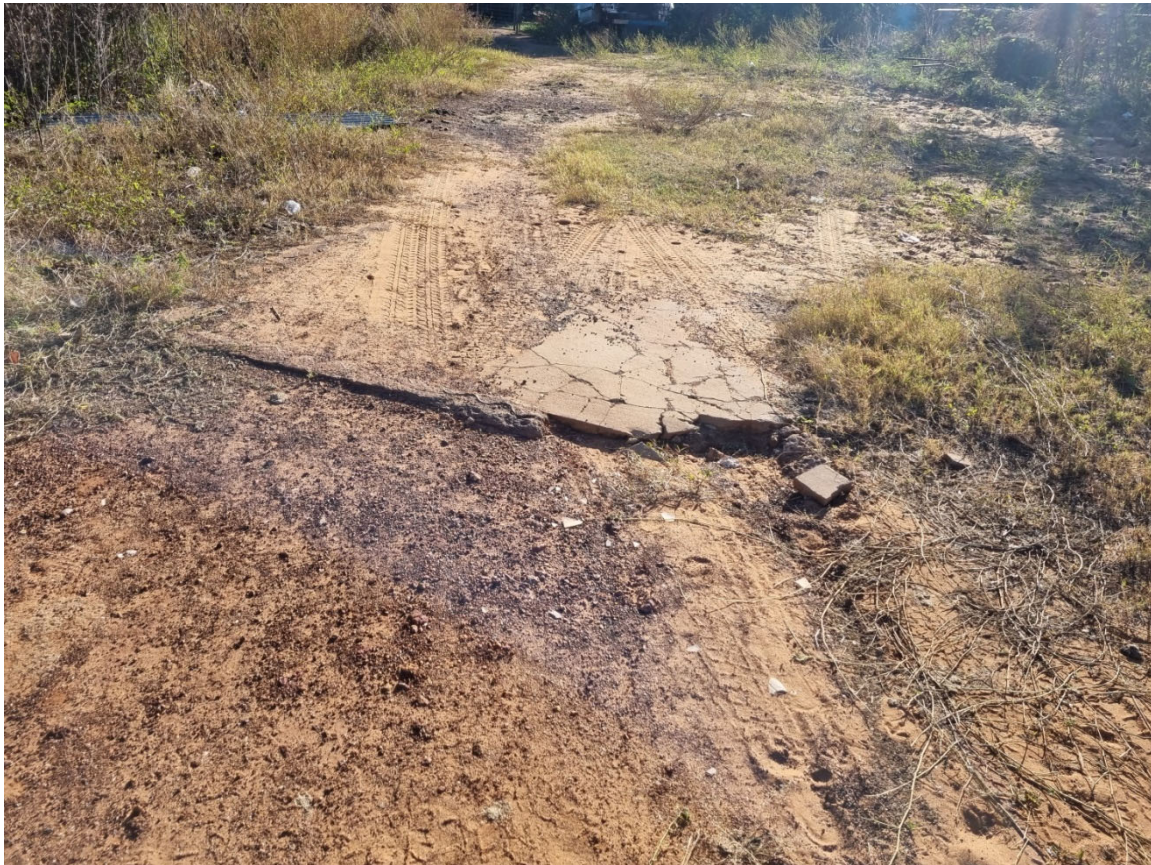
In addition to the exposed slab, it is likely that there are additional buried elements given the poor surface condition of the site.

Photo 3 – Exposed concrete slab

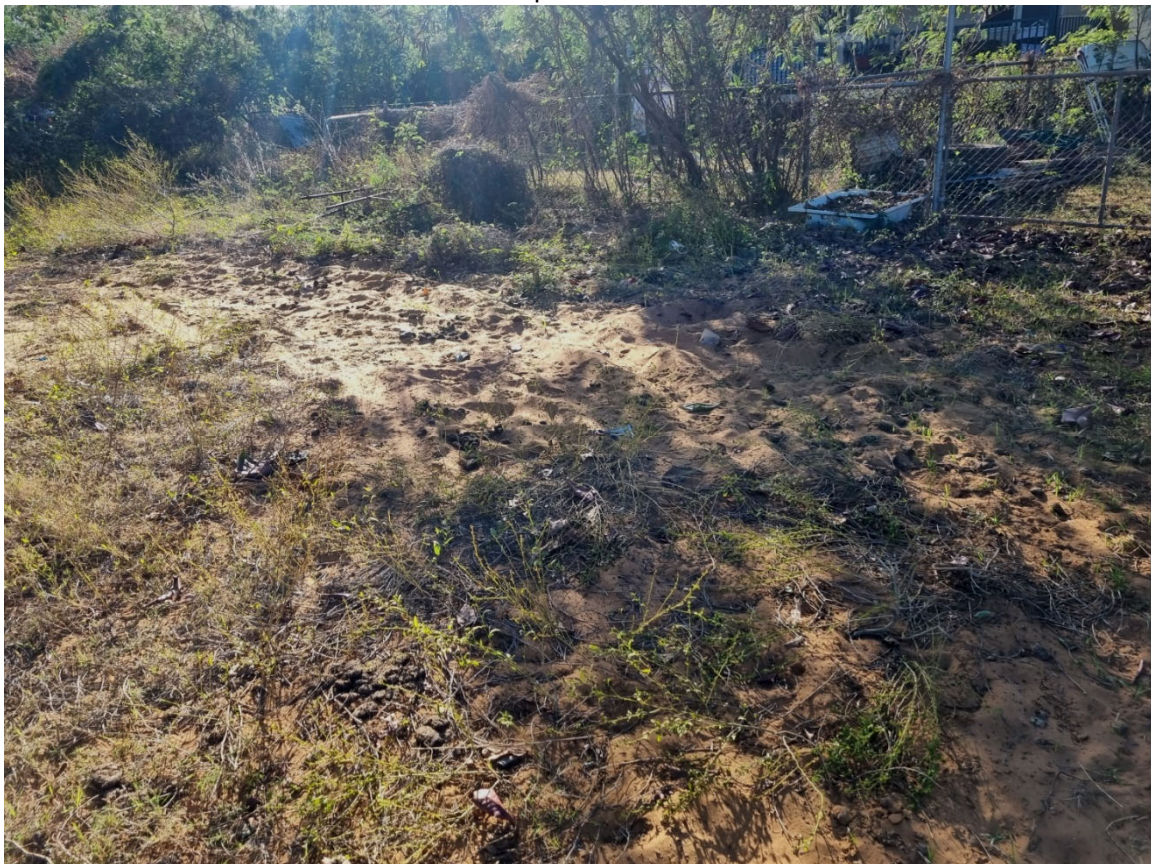
Photo 4 – Imported fine grained sand

Where fill is to be placed, all topsoil, loose material, organic material and uncontrolled fill is to be removed from the site prior to importing of any engineered material. Based on the long term loadings anticipated to be present within the proposed buildings, settlement predictions based on the depth of fill may need to be undertaken following receipt of final design levels if the foundations are not keyed into natural ground. Alternatively, building articulation can be integrated into the building’s structural design that will allow the building to accommodate such movements.

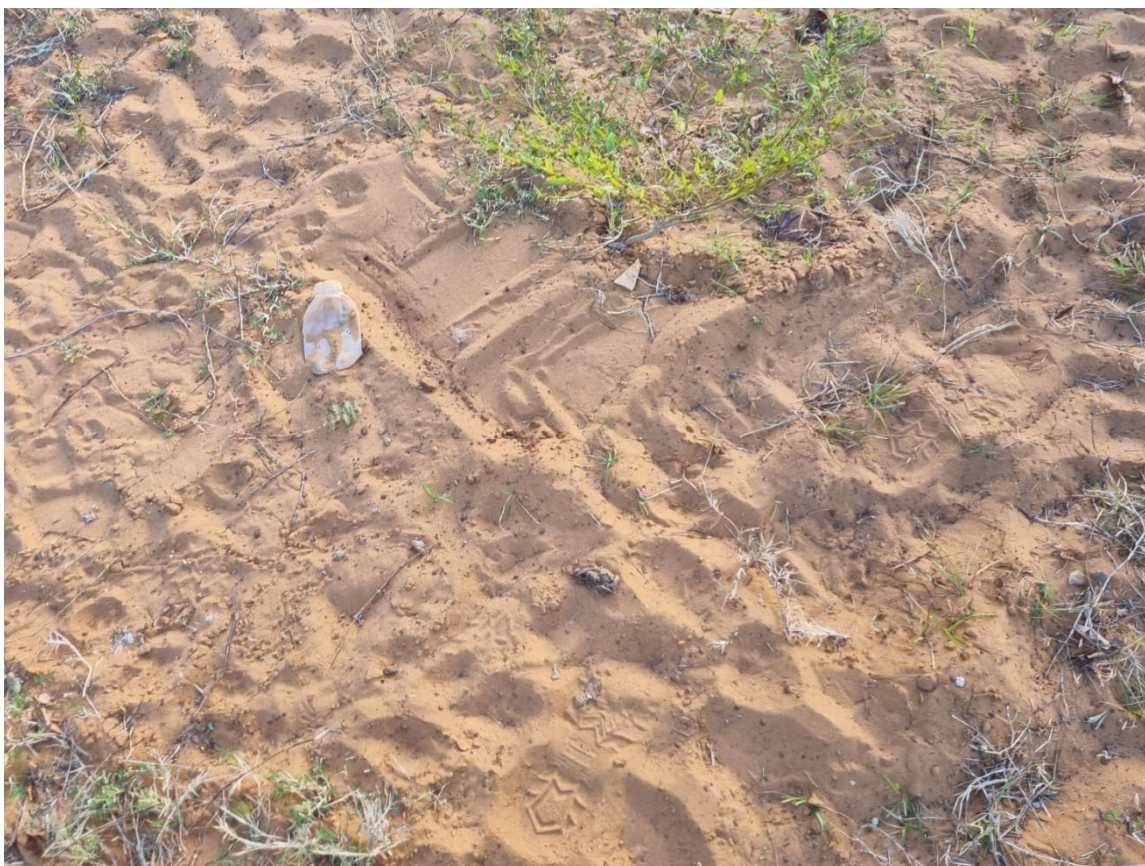
Photo 5 – Imported fine grained sand

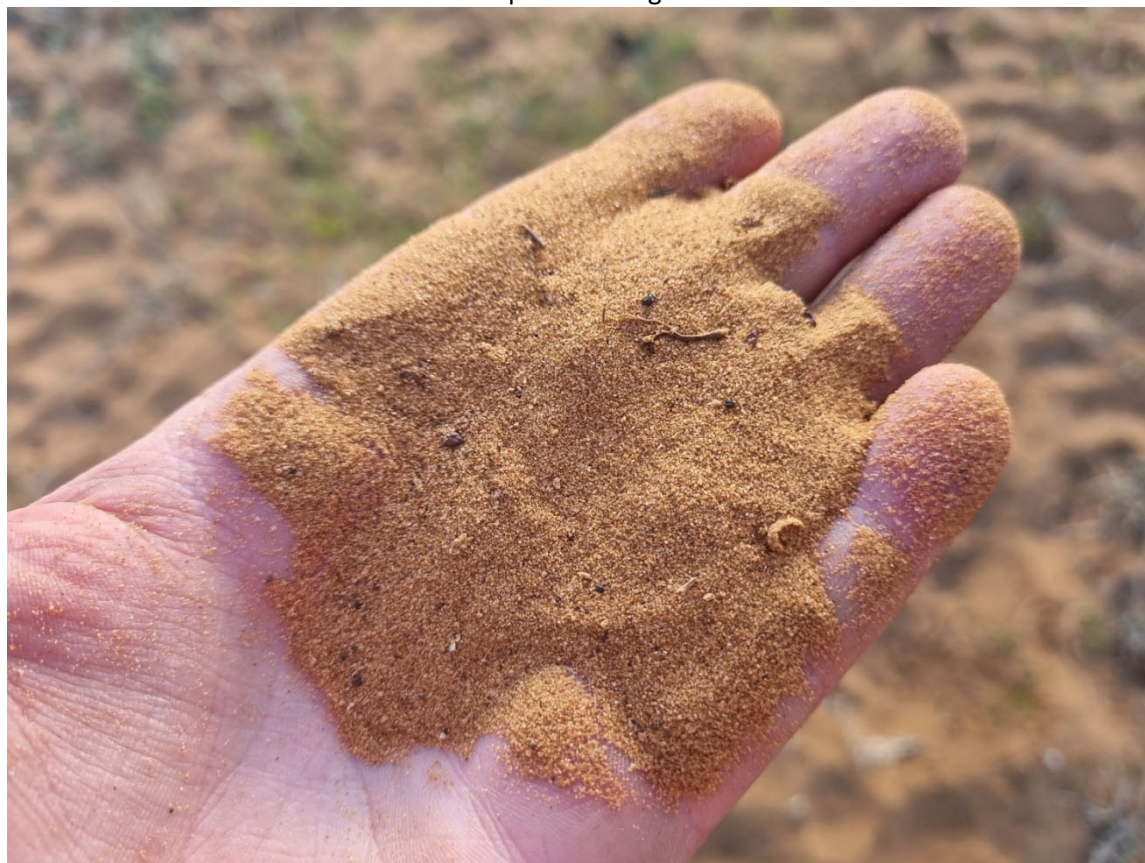
Photo 6 – Imported fine grained sand

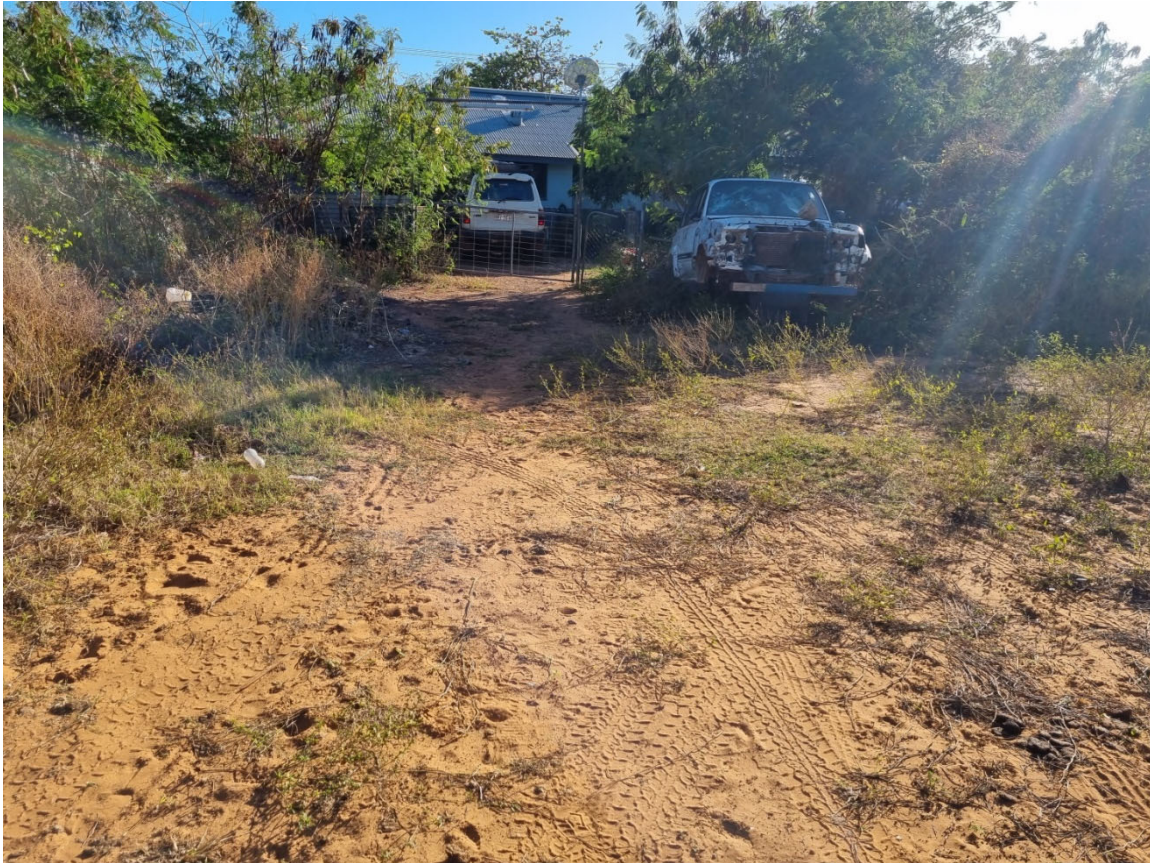
Photo 7 – Old car at rear of site and track

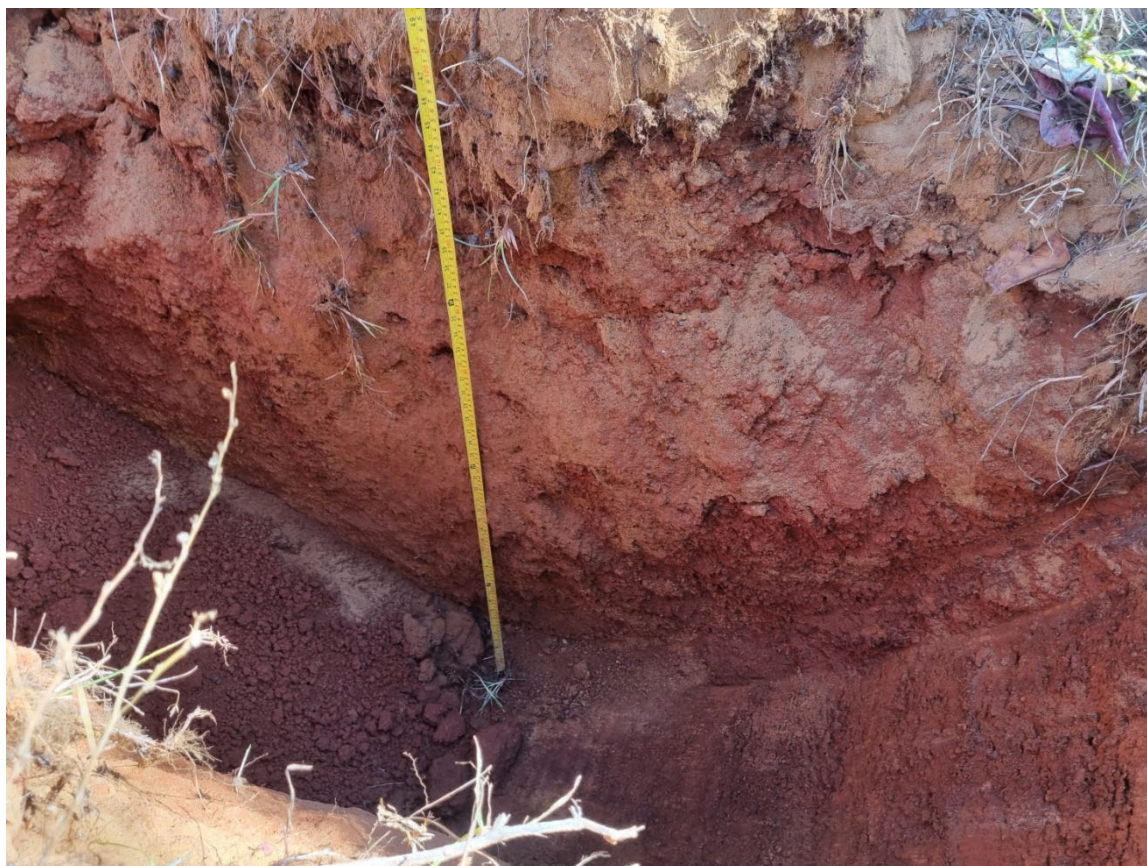
Encountered ground conditions in TP1 were fine grained Sand fill (beach sand) to a depth of 0.2m, dark brown Silty Clay to a depth of 0.3m underlain by Gravelly Silt to refusal depth of 1.3m. The proportion of gravel increased with depth and one cemented cobble was encountered. Exposed laterite was visible at the surface at one location, indicating variable depth to laterite throughout the site. No groundwater was observed in the test pit.

Photo 9 – TP1

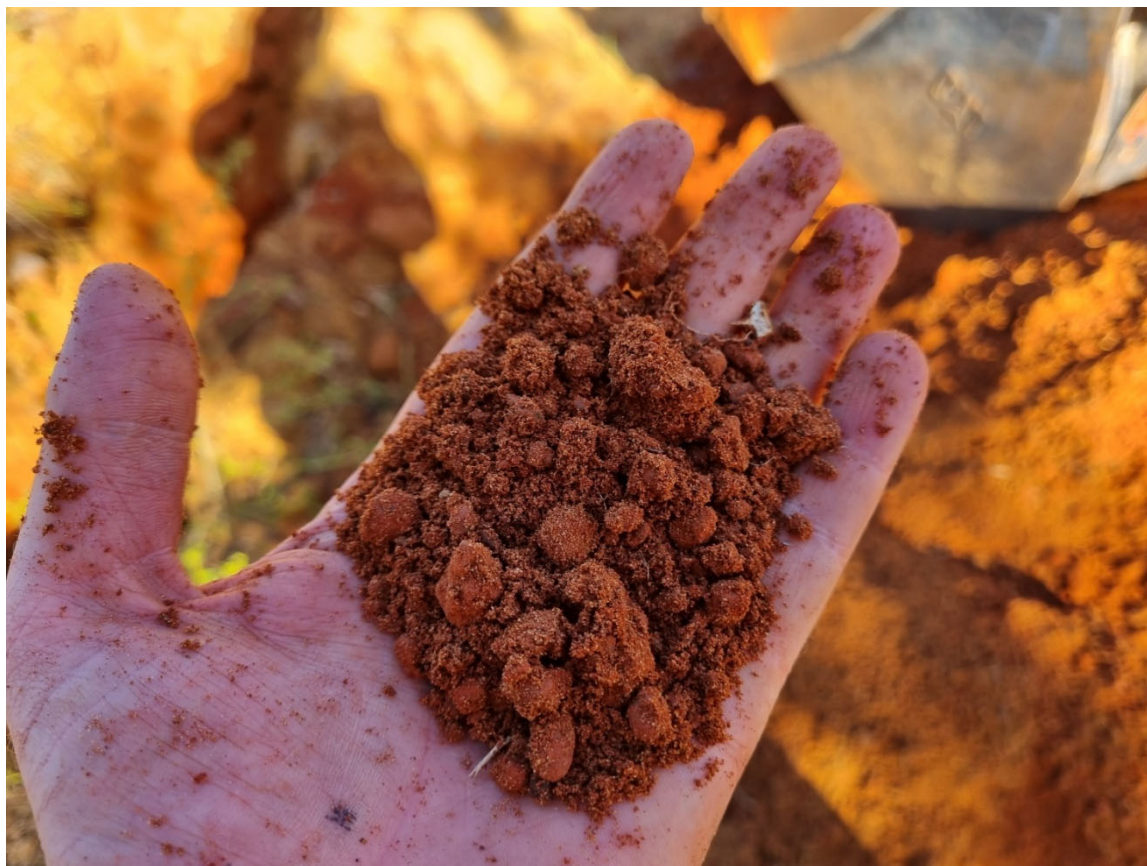
Photo 10 – Silty gravel from TP1

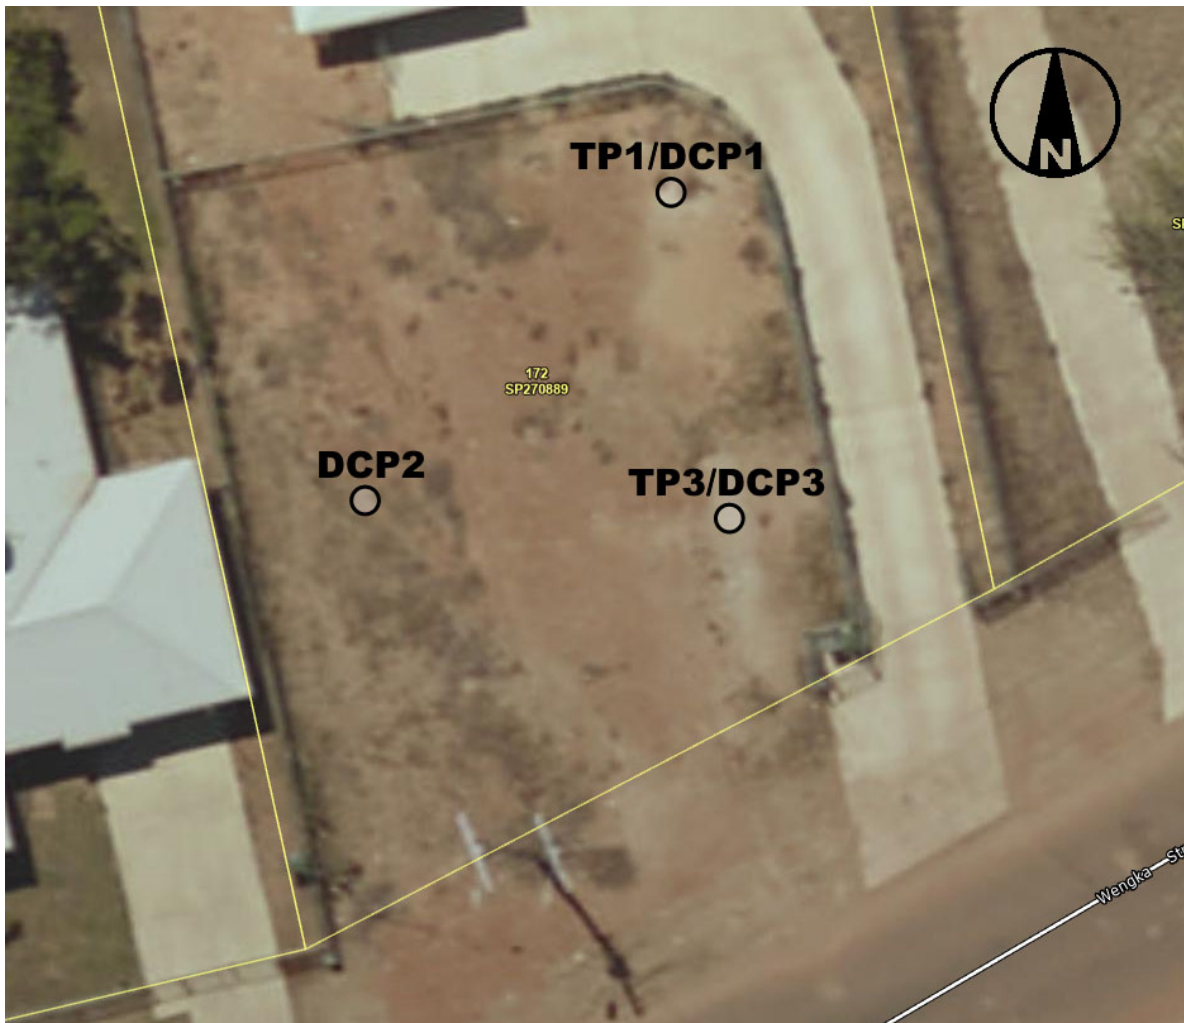
Test locations are shown in Figure 1. A test pit at DCP2 could not be conducted due to an overhead cable.

Figure 1 - Test locations

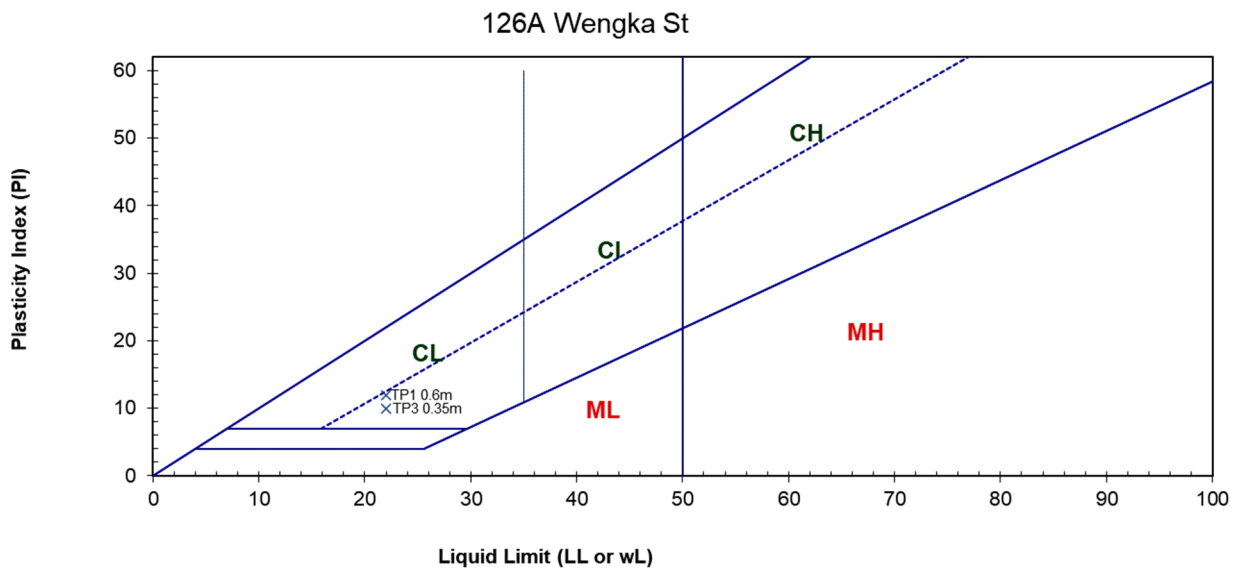
Sample	Liquid Limit (%)	Plastic Limit (%)	Plasticity Index	Linear Shrinkage	Emerson Class	Gravel Proportion (%)	Sand Proportion (%)	Fines Proportion (%)
TP1 0.6m	22	10	12	4	4	28	32	40
TP3 0.35m	22	12	10	5.5	5	23	31	46

Figure 2 - Atterberg A-line graph

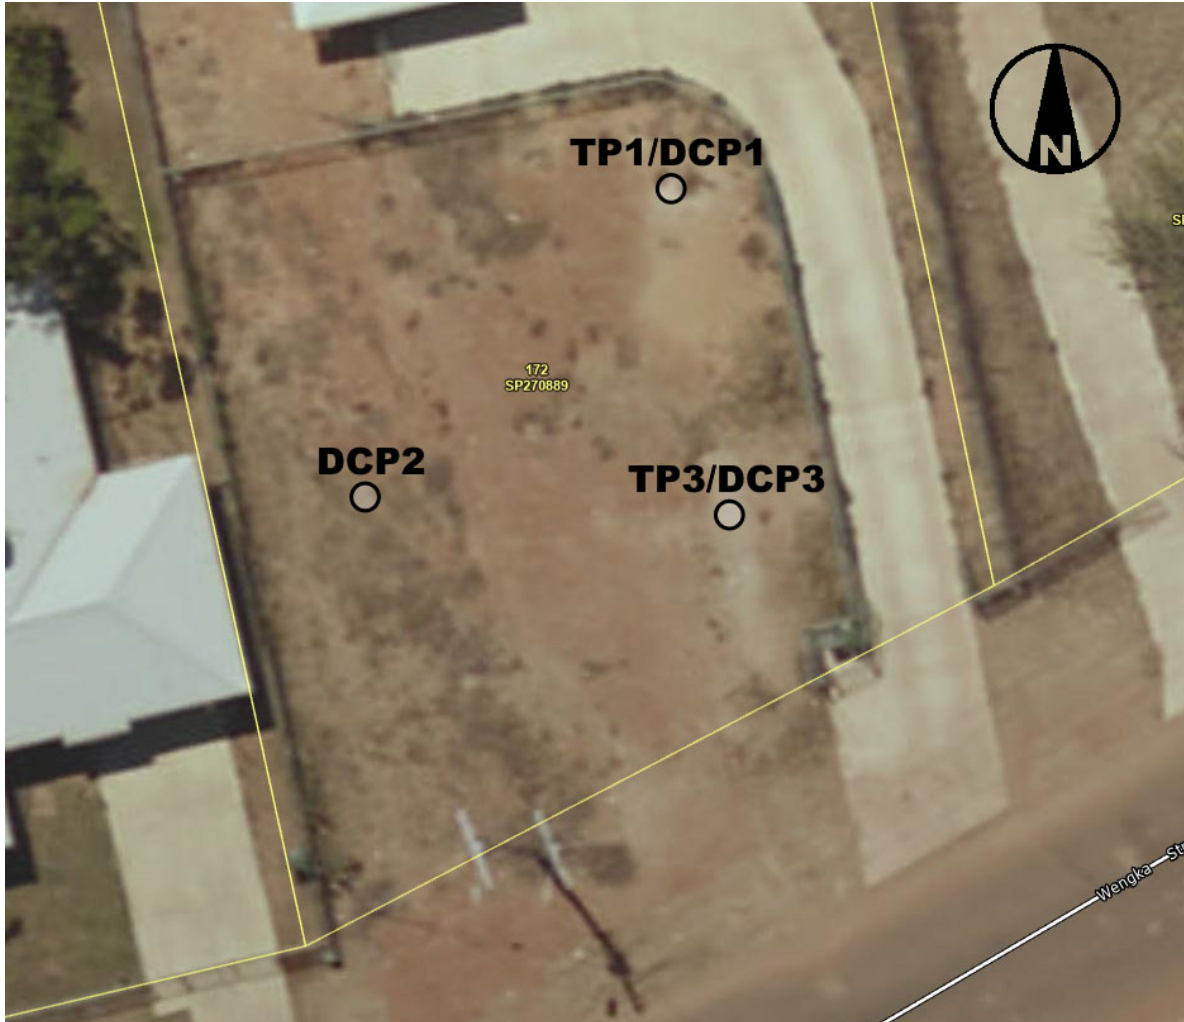
APPENDIX A. TEST PIT/DCP LOGS

LOCATION	EASTING (GDA2020)	NORTHING (GDA2020)
22260_3 TP1/DCP1	306513.50	8156437.64
22260_3 DCP2	306504.41	8156428.37
22260_3 TP3/DCP3	306515.29	8156427.92

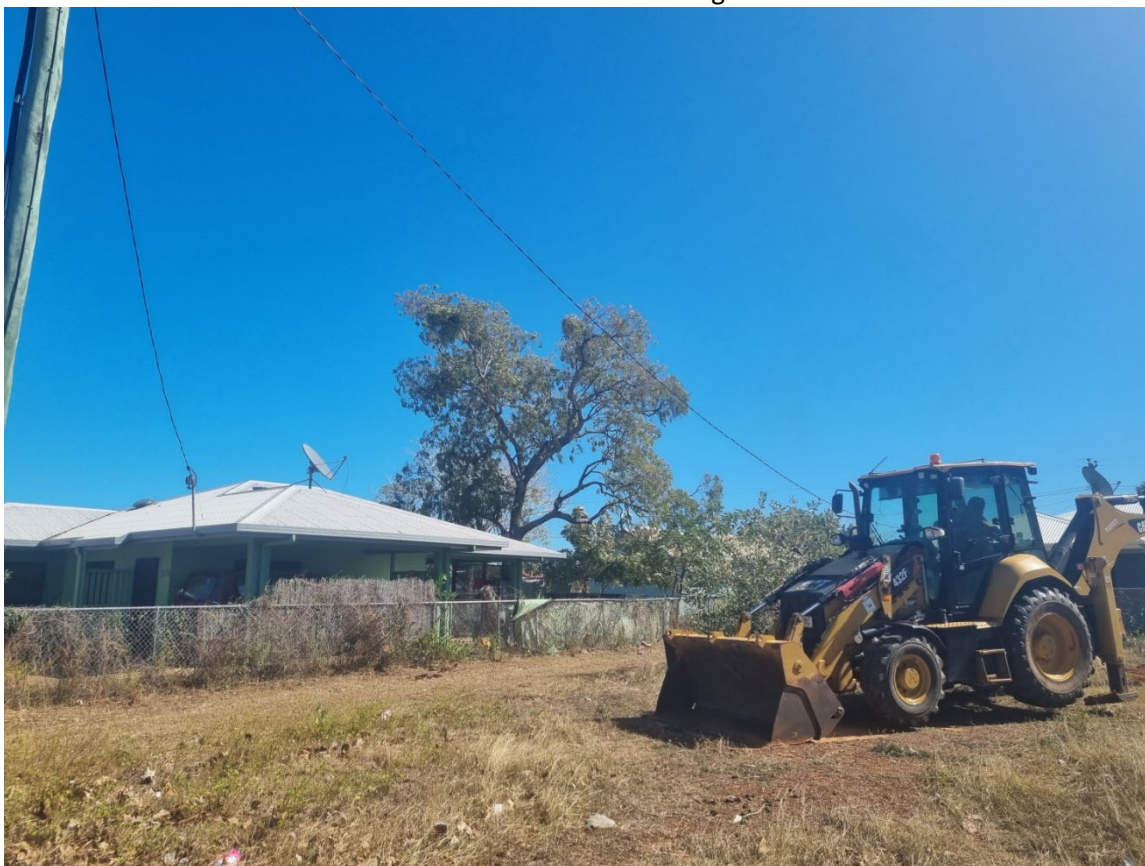
Photo 2 – Overhead cable preventing excavation of TP2

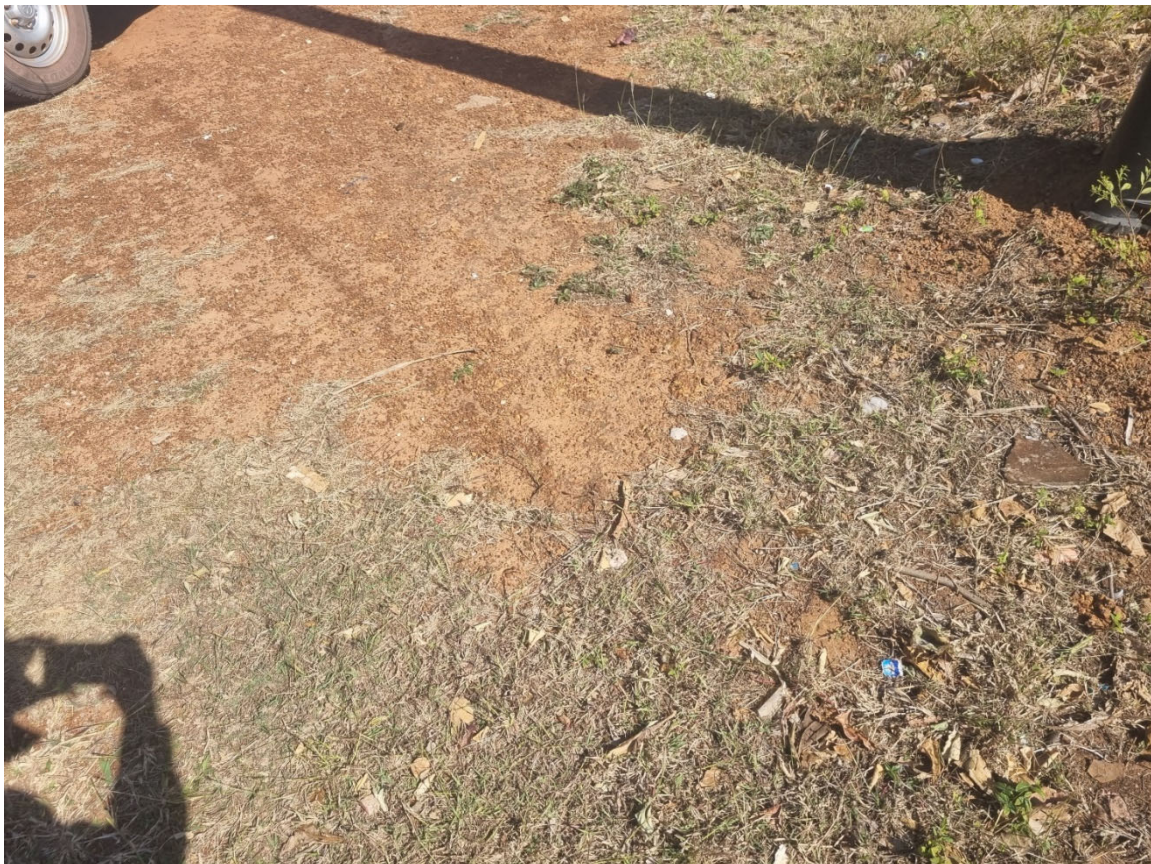
Photo 4 – Exposed laterite

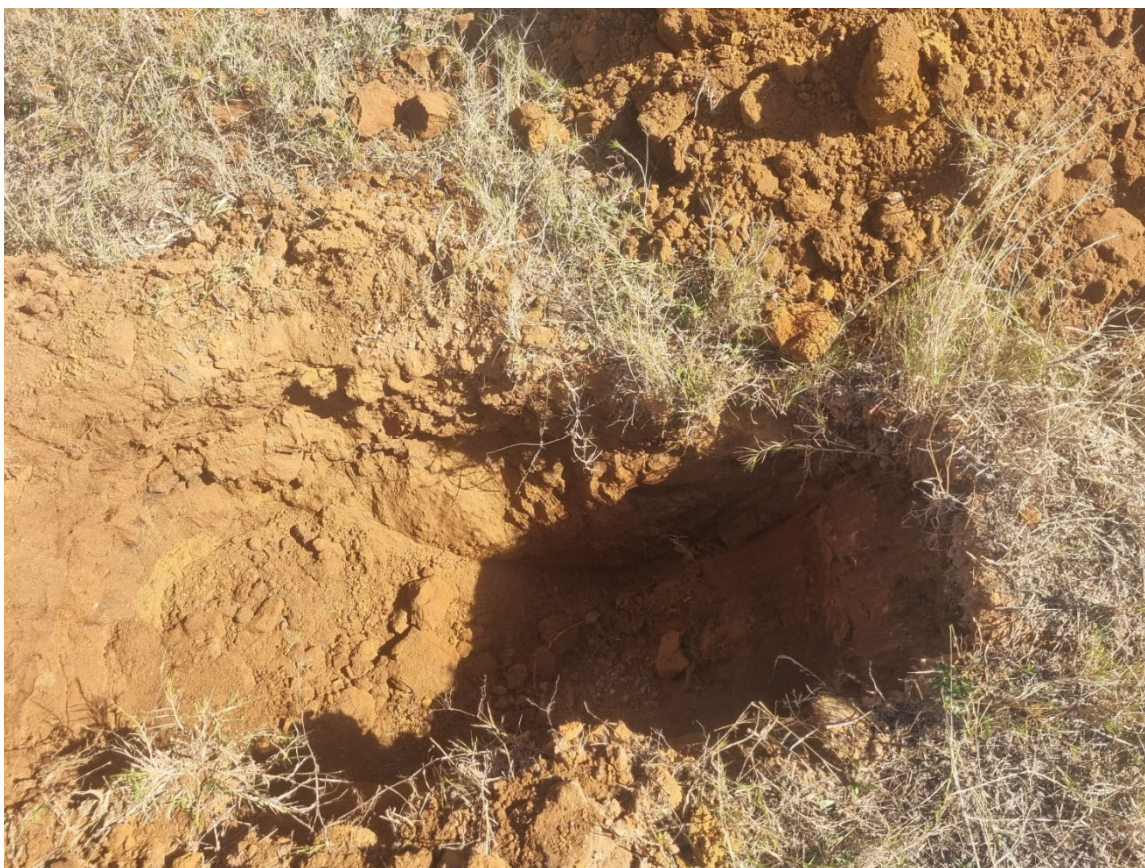
Photo 5 – TP1

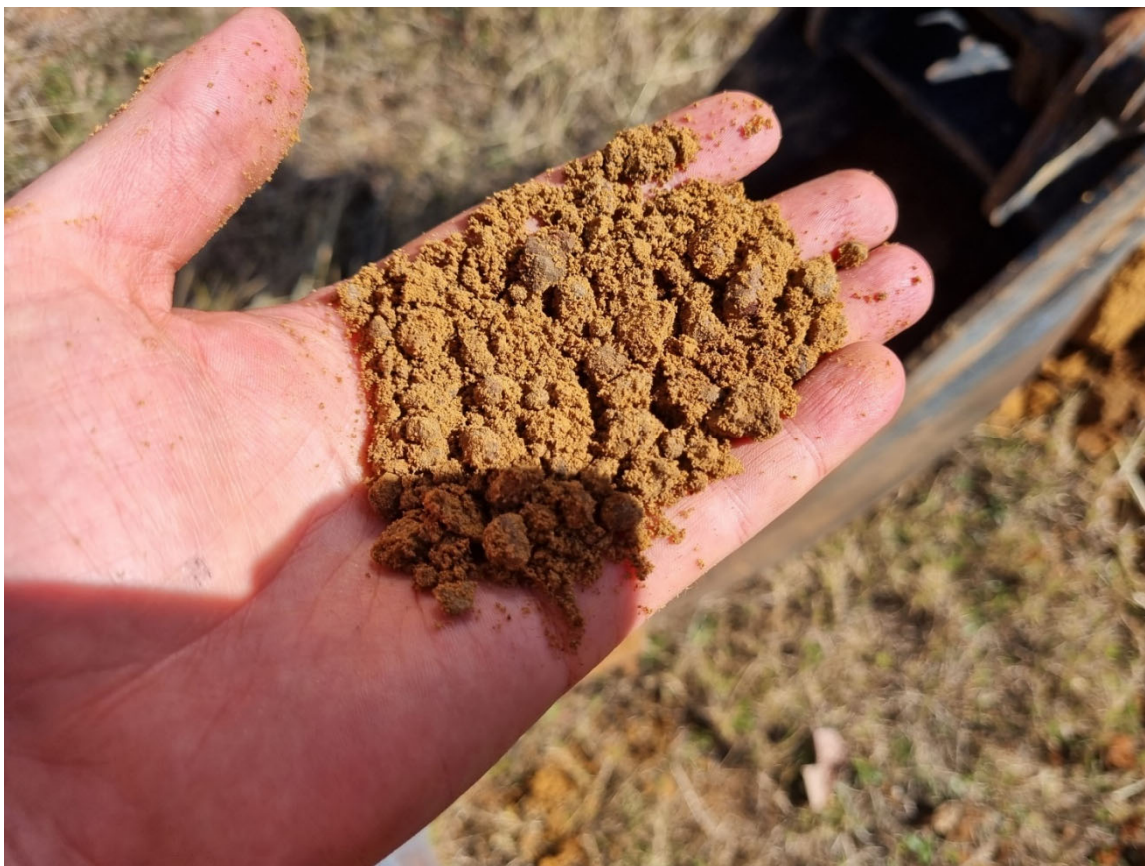
Photo 6 – Silty, Gravelly Clay from TP1

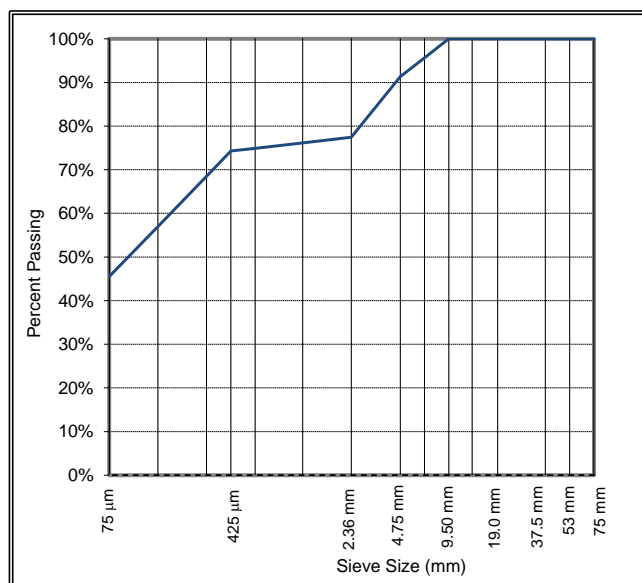
Particle Size Distribution			
Test Method AS1289.3.6.1			
A.S.	Specification		Result
	Specification	Result	Specification
Sieve Size	Minimum	% Passing	Maximum
75mm		100	
53mm		100	
37.5mm		100	
19.0mm		100	
9.5mm		100	
4.75mm		91	
2.36mm		77	
0.425mm		74	
0.075mm		46

Plasticity Tests	Test Method	Specification Minimum	Result	Specification Maximum
Oven Dried - Dry Sieved				
Liquid Limit (%)	AS1289.3.1.2		22	
Plastic Limit (%)	AS1289.3.2.1		12	
Plasticity Index	AS1289.3.3.1		10	
Linear Shrinkage (%)	AS1289.3.4.1 *		5.5	
P.I. X % Passing 0.425mm (WPI)			740	
L.S. X % Passing 0.425mm			409	
Ratio of % Passing (0.075 / 0.425)			0.61

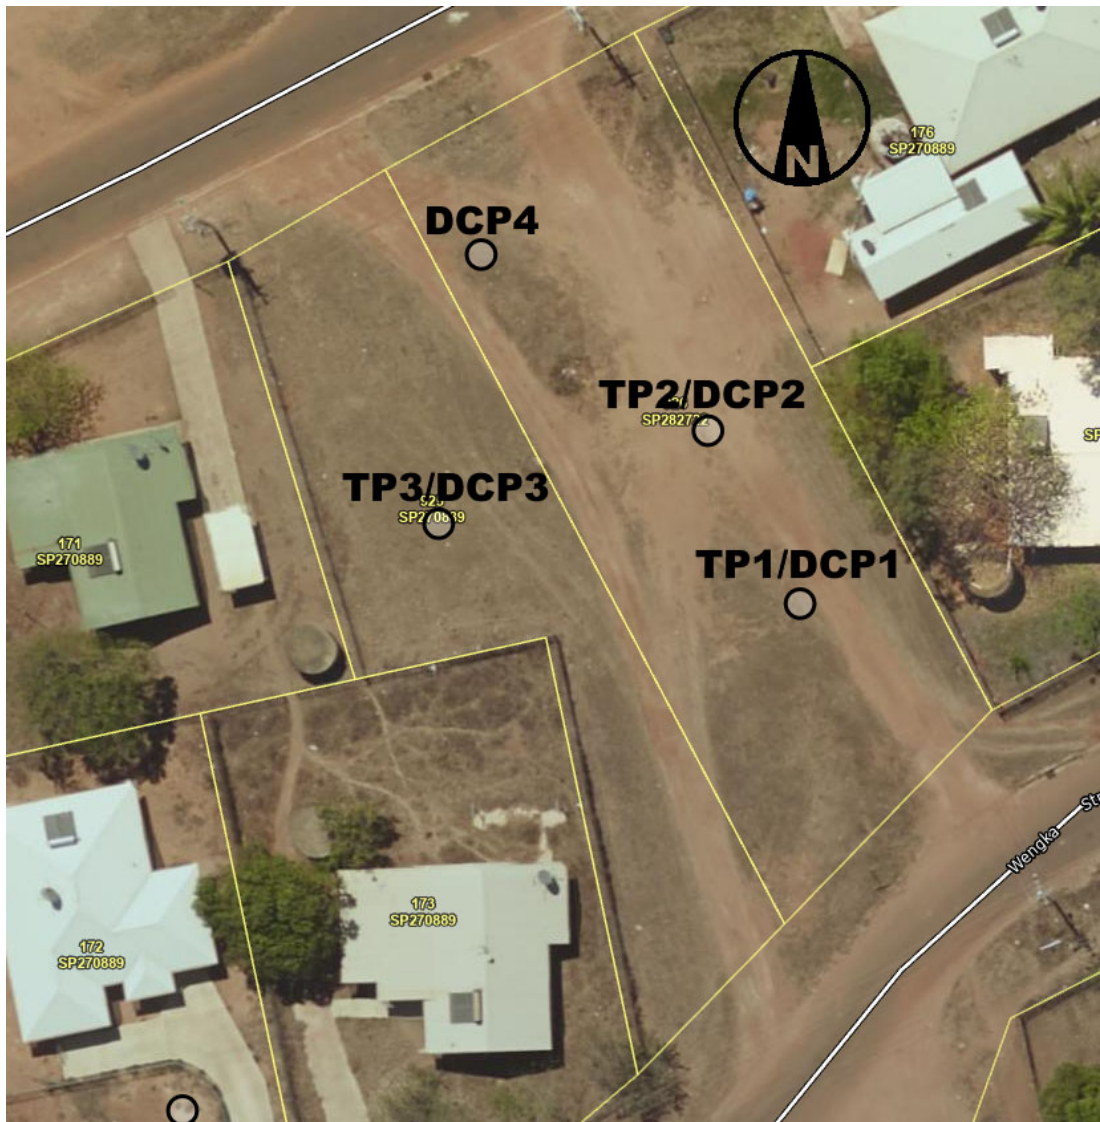
Test locations are shown in Figure 1.

Figure 1 - Test Locations

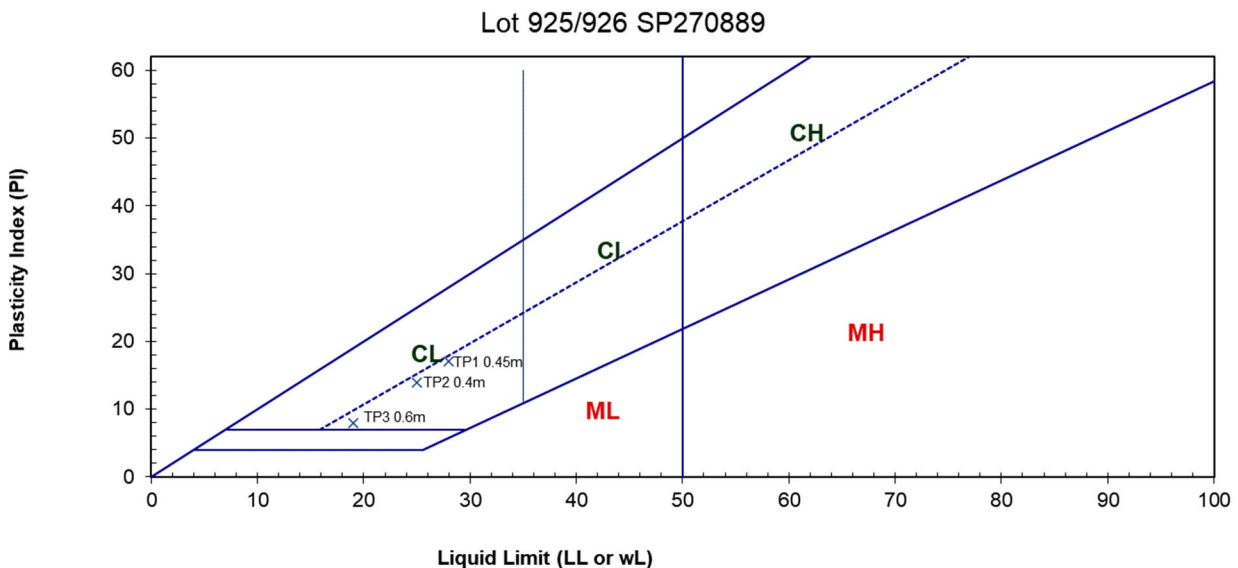
Sample	Liquid Limit (%)	Plastic Limit (%)	Plasticity Index	Linear Shrinkage	Emerson Class	Gravel Proportion (%)	Sand Proportion (%)	Fines Proportion (%)
TP1 0.45m	28	11	17	7.5	4	30	28	42
TP2 0.4m	25	11	14	7	4	29	27	44
TP3 0.6m	19	11	8	5	4	20	49	31

Figure 2 - Atterberg A-line graph

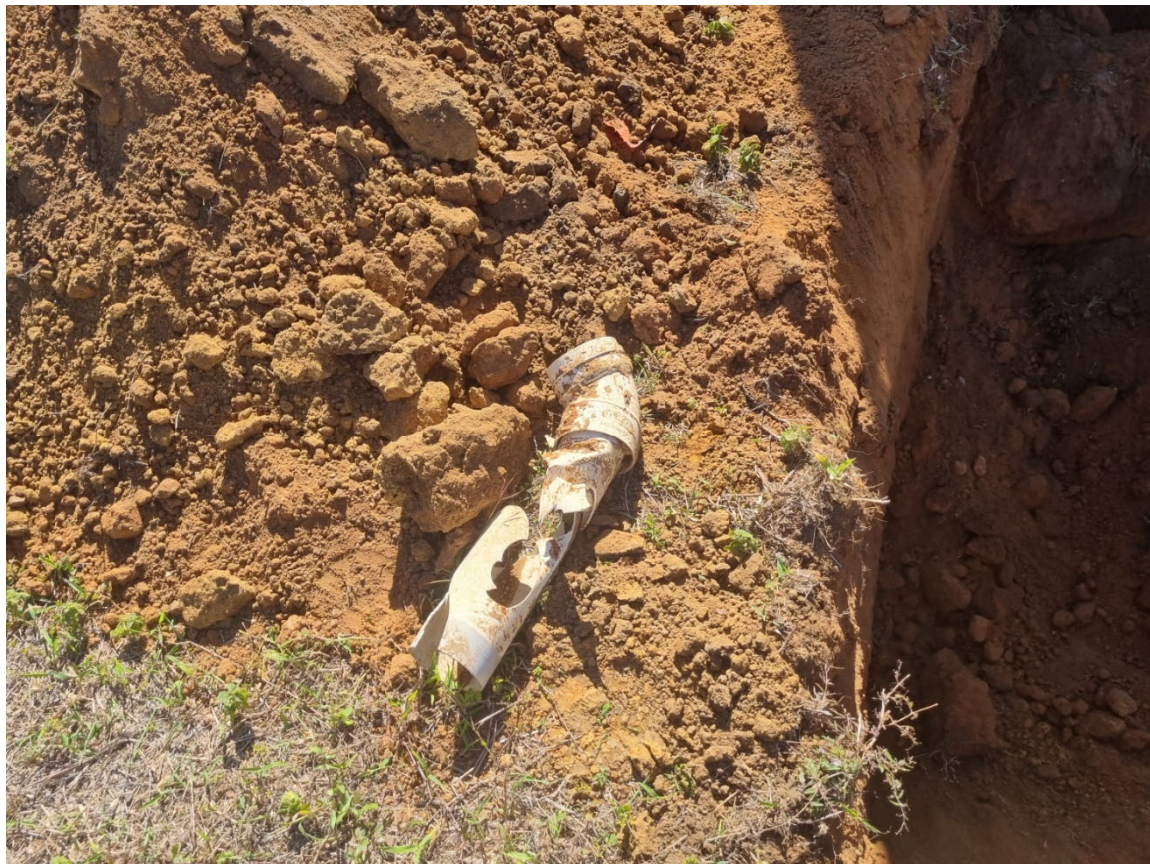
Photo 6 – PVC pipe extracted from TP3

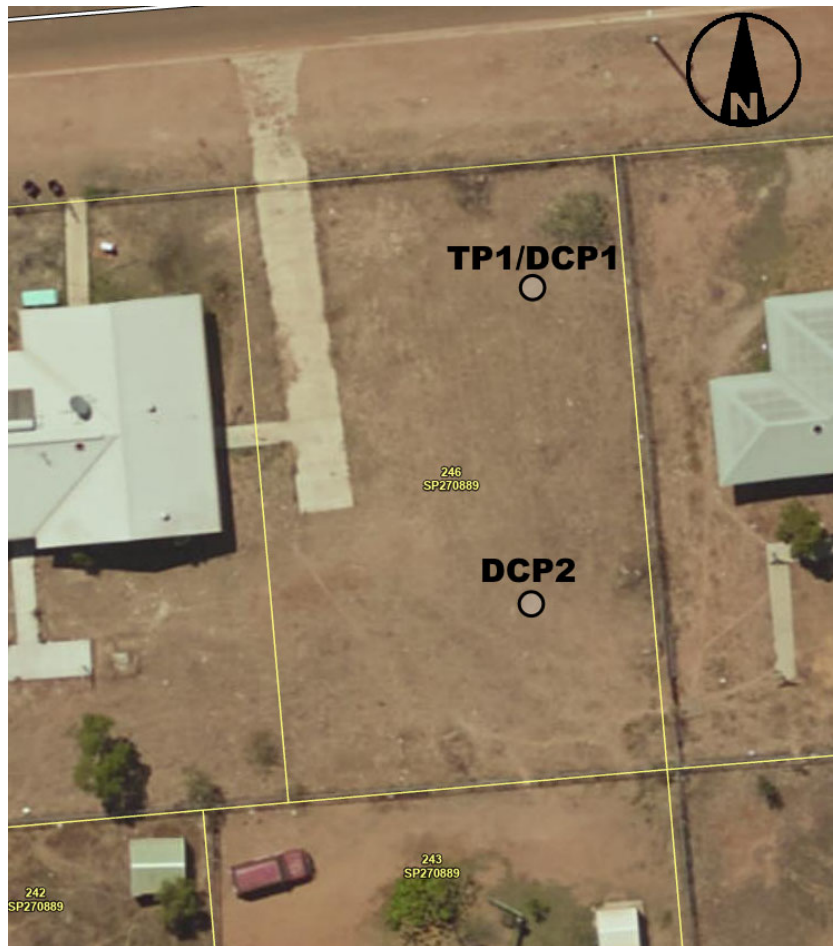
Test locations are shown in Figure 1.

Figure 1 - Test locations
