Tender No: MSC-2024-001

Forward Remote Capital Program

APPENDIX 1

Subject: Geotechnical Investigation – 254 Wardirrkkan Street, Gununa, Mornington Island

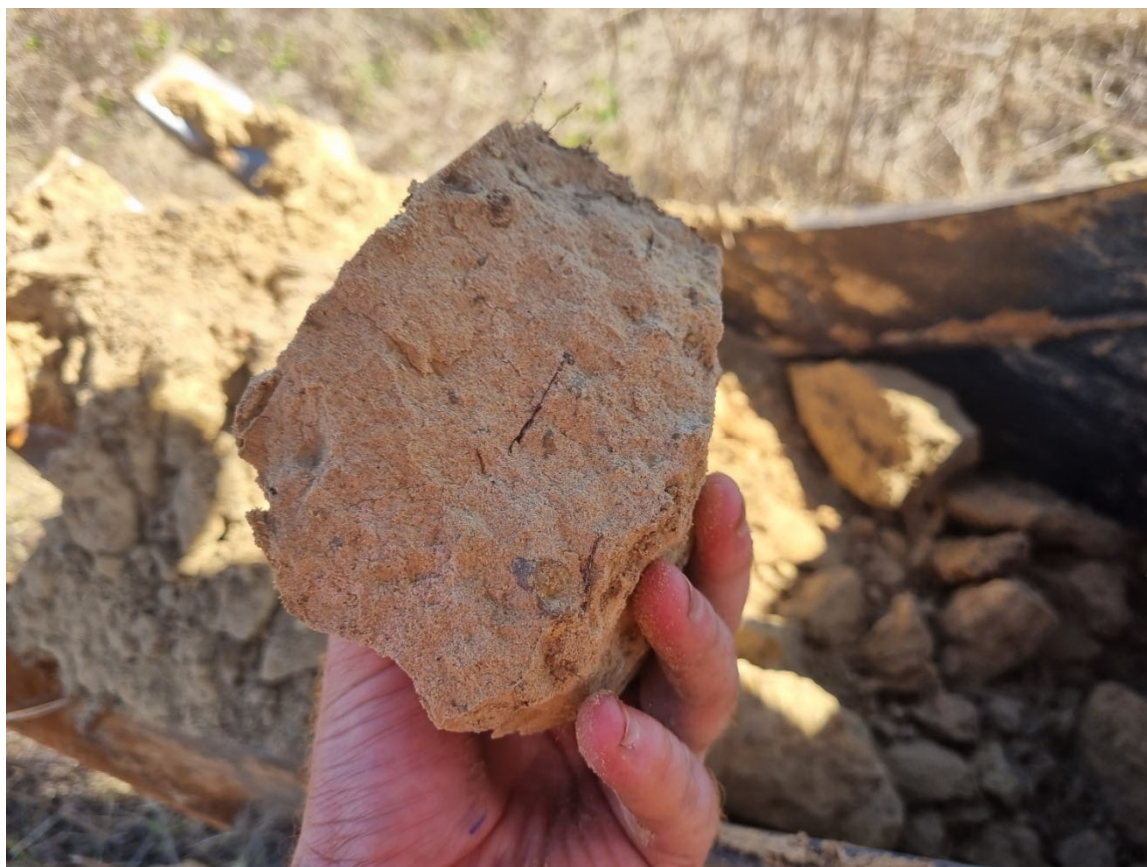
Photo 3 – Sandy Silt clump

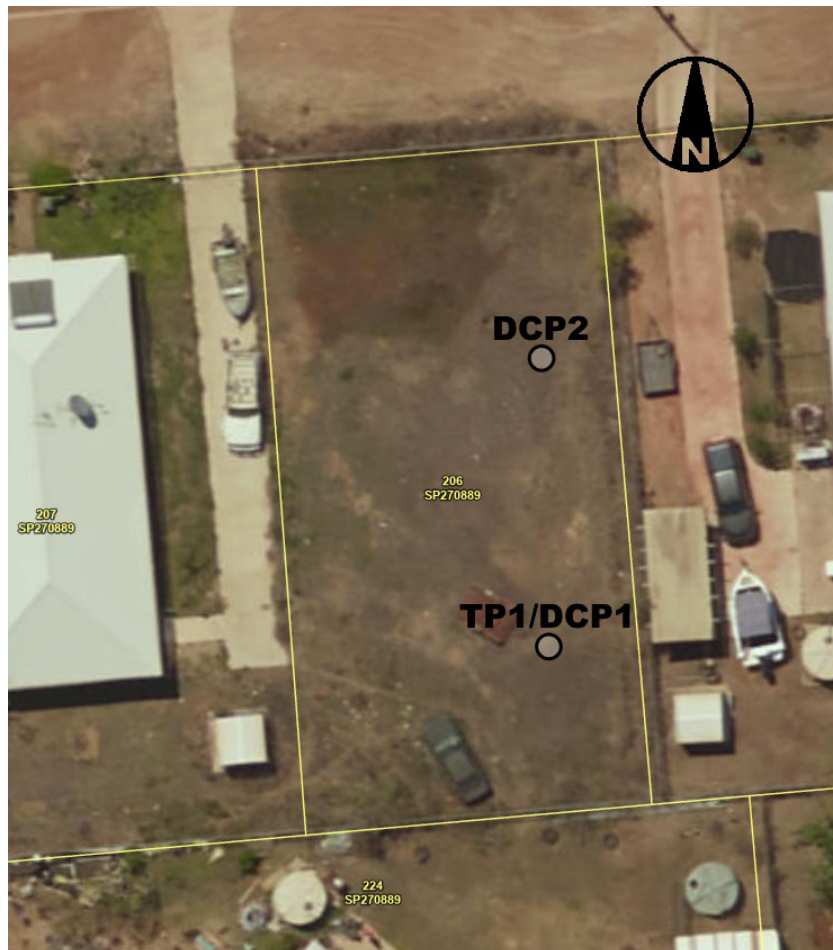
Test locations are shown in Figure 1.

Figure 1 - Test locations

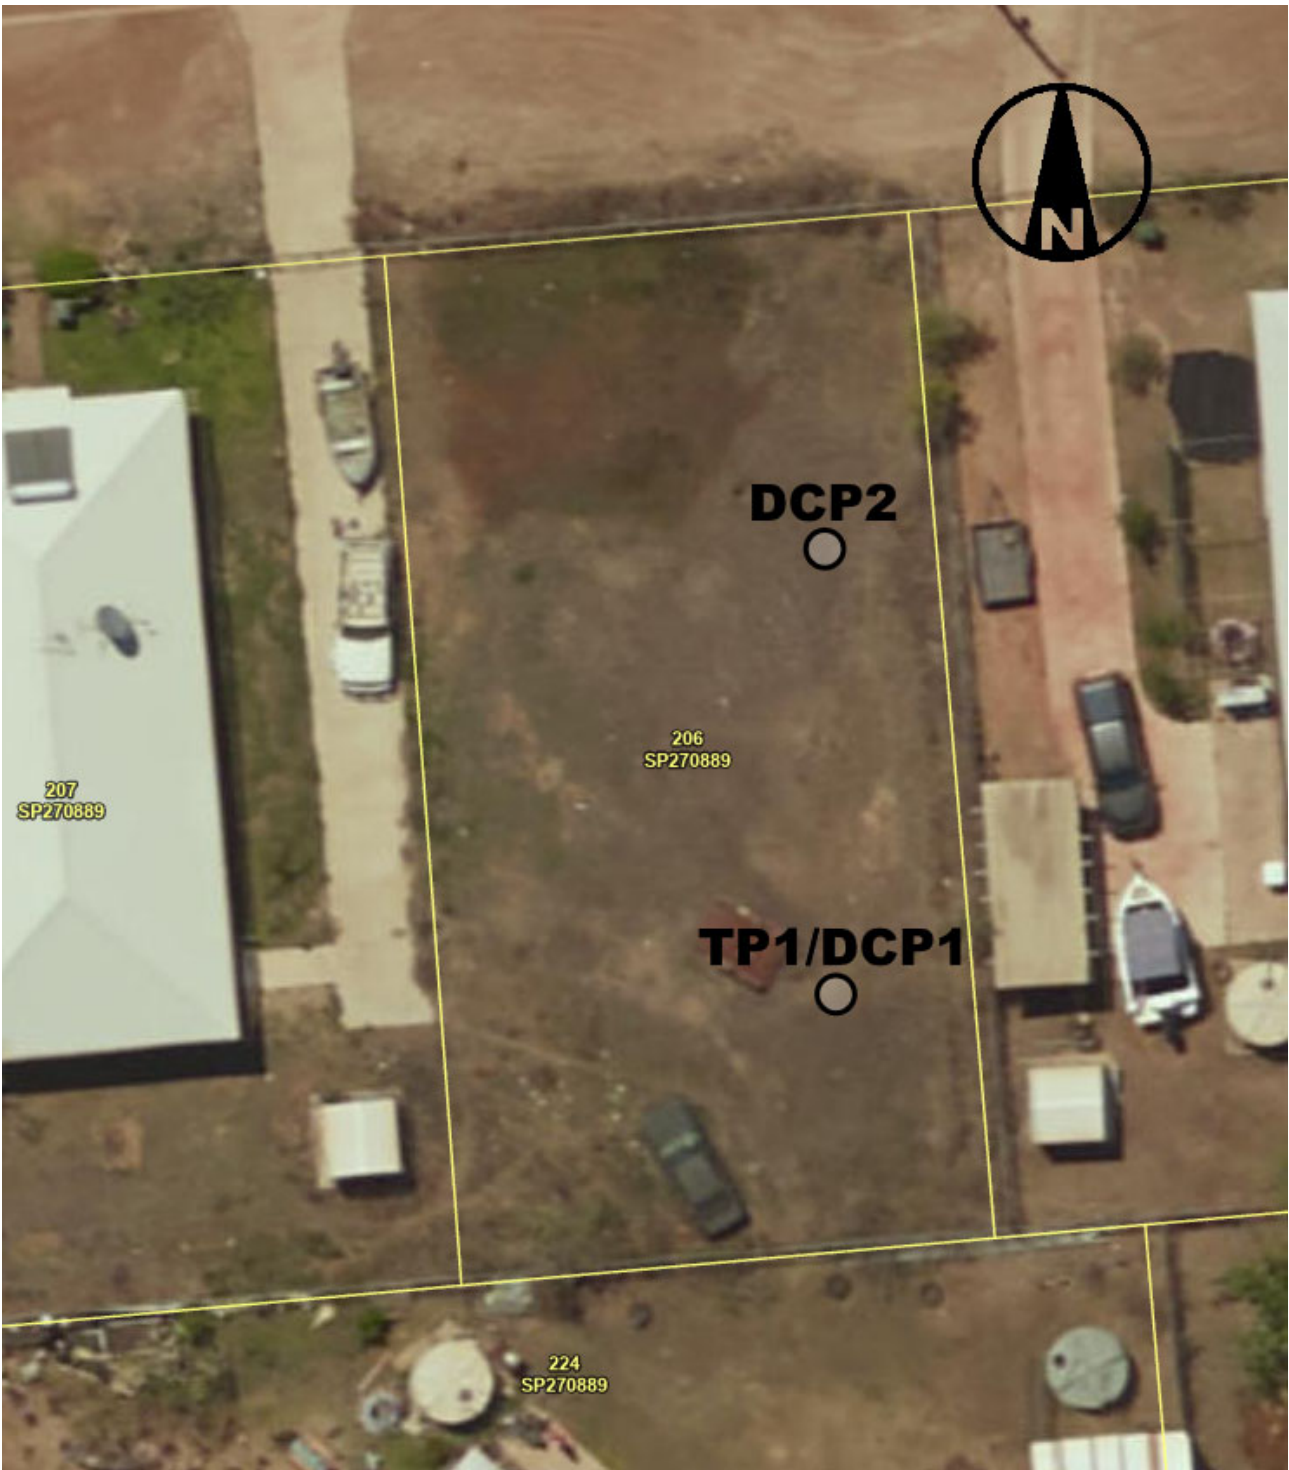
APPENDIX A. TEST PIT/DCP LOGS

LOCATION	EASTING (GDA2020)	NORTHING (GDA2020)
22260_6 TP1/DCP1	306759.02	8156820.49
22260_6 DCP2	306759.58	8156806.21

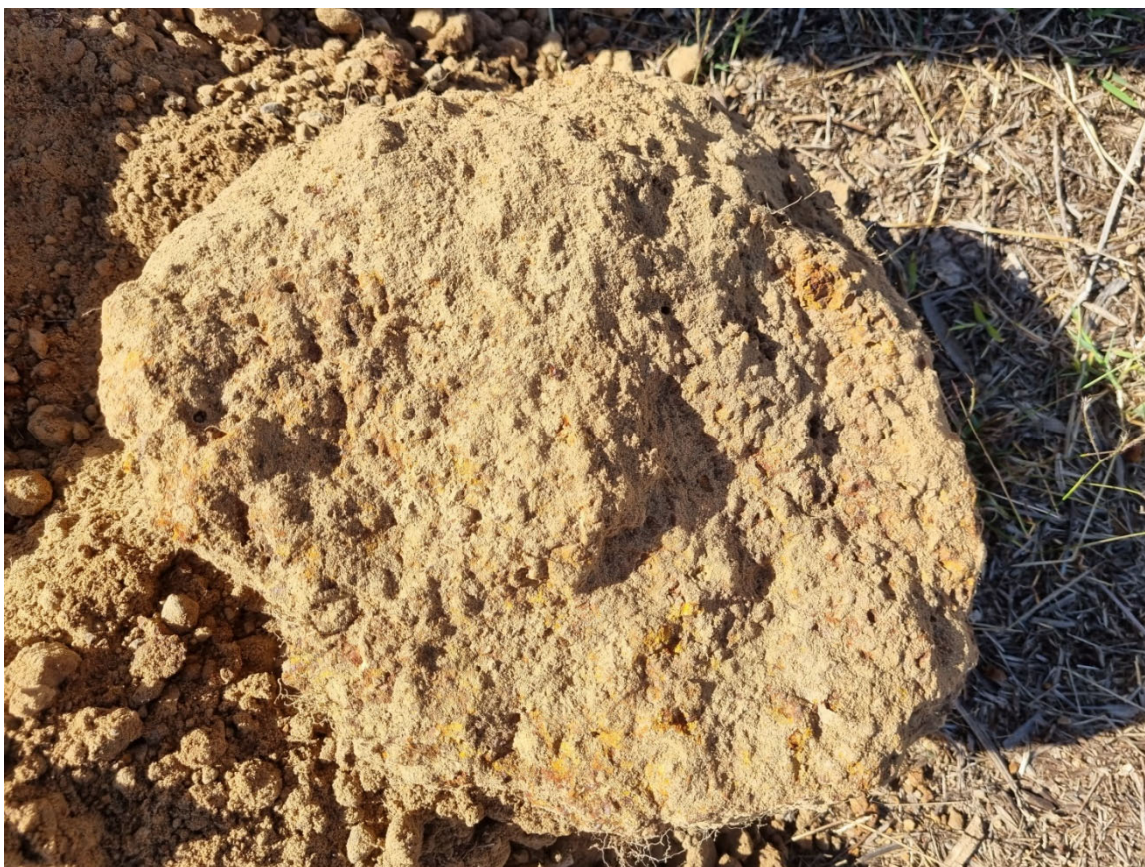
Photo 3 – Laterite extracted as cobble
